Case Study

Refueling Bunded Area Crown Bus Lines

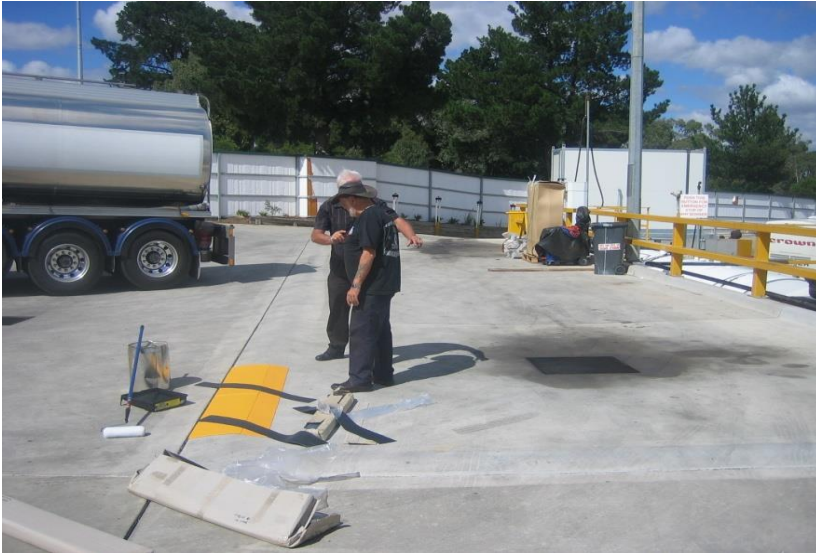
The refueling area at Crown Bus lines was bunded by a Raised Concrete edge
As the rest of the area was concrete it was very hard to identify as a result there was many injuries with ankles and backs.

The refueling bunded area. It is very hard to identify the raised bunds.

AWIS Preform was consulted and provided a non skid preform to cover the raised bunded area. AWIS Preform suggested a yellow black cross hatched as identification.

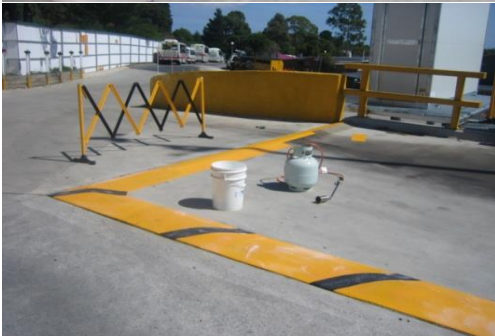
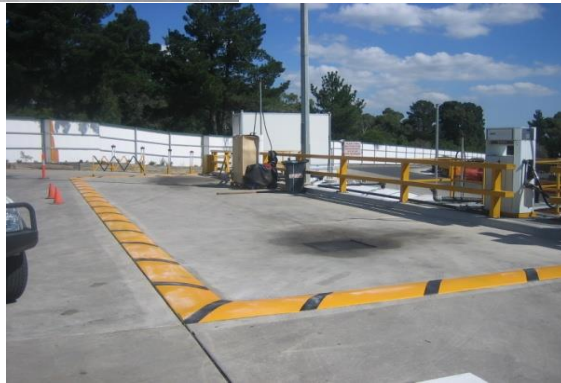
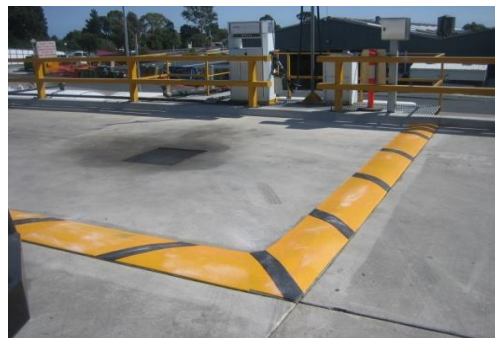
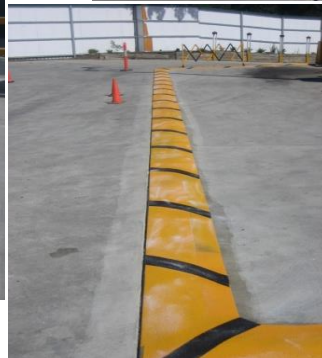
The AWIS Preform highlights the bunded area and as it is anti slip it is safe to walk over and the retroreflectivity allows it to be identified when the headlights of the buses shine on it.
